DAM REMOVAL PROGRESS 2023

DAM
REMOVAL
EUROPE

All-time record in removed barriers

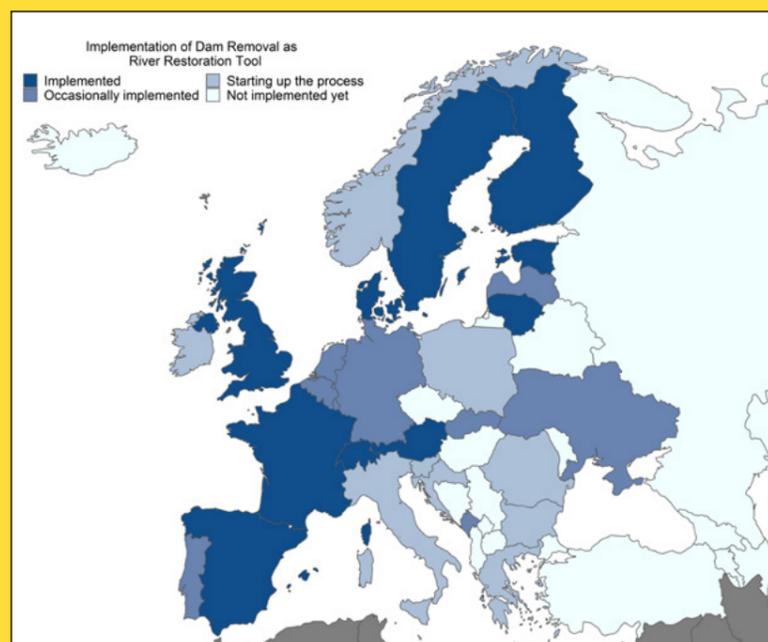
Figure 1. Implementation of dam removal as a river restoration tool in Europe. Note: barrier removals which took place in England, Scotland, Wales and Northern Ireland are considered under UK as a single unit

Lately, the tide is turning and barrier removal is recognized as an effective and useful river restoration tool in Europe. The number of barrier removals¹ increases year after year (Table 1) and new European countries are starting to implement this practice to restore river connectivity and ecological continuity. Most barrier removals occur in western and northern Europe, where barrier density is highest, but this restoration tool is gaining attention in other European regions too, like the Balkans. Mainstreaming barrier removal in regions and countries with relatively unfragmented rivers is imperative and timely, to hamper the accelerating pressure for hydropower development. Dam Removal Europe (DRE) coalition publishes a progress report on an annual basis to evaluate the advancement in the implementation of EU policies and to analyse the progress and impact of dam removal utilization as a river restoration measure in each European country (Figure 1).

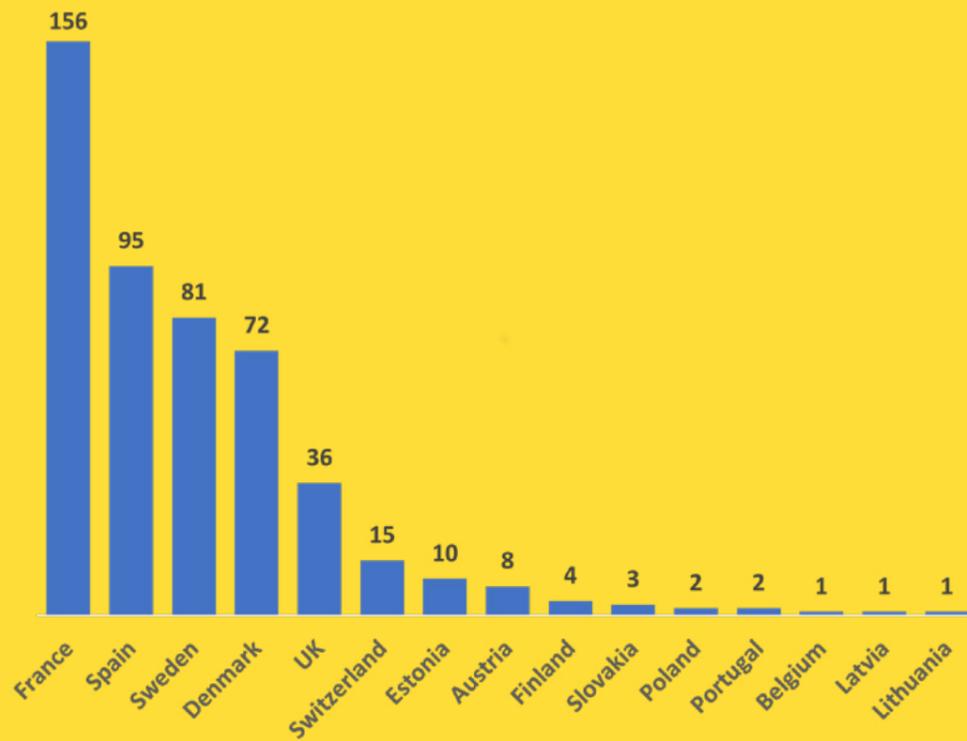
Figure 2. Number of removed barriers per country in 2023. Note: UK removals include 20 removals from England, 13 from Wales and 3 from Scotland

- ✂ At least 487 barriers were removed in 15 European countries (Figure 2)
- ✂ France was the trailblazer of barrier removal in Europe (Figures 2-3), followed by Spain, Sweden and Denmark
- ✂ 46% of the removed barriers were weirs and 36% were culverts³. Dams were the next most common type of the removed barriers (12%), followed by ramps, sluices and fords
- ✂ 78% of the removed barriers were lower than 2 m, 20% were 2-5 m high and 2% were more than 5 m high⁴
- ✂ More than 4300 km were reconnected through barrier removals⁵

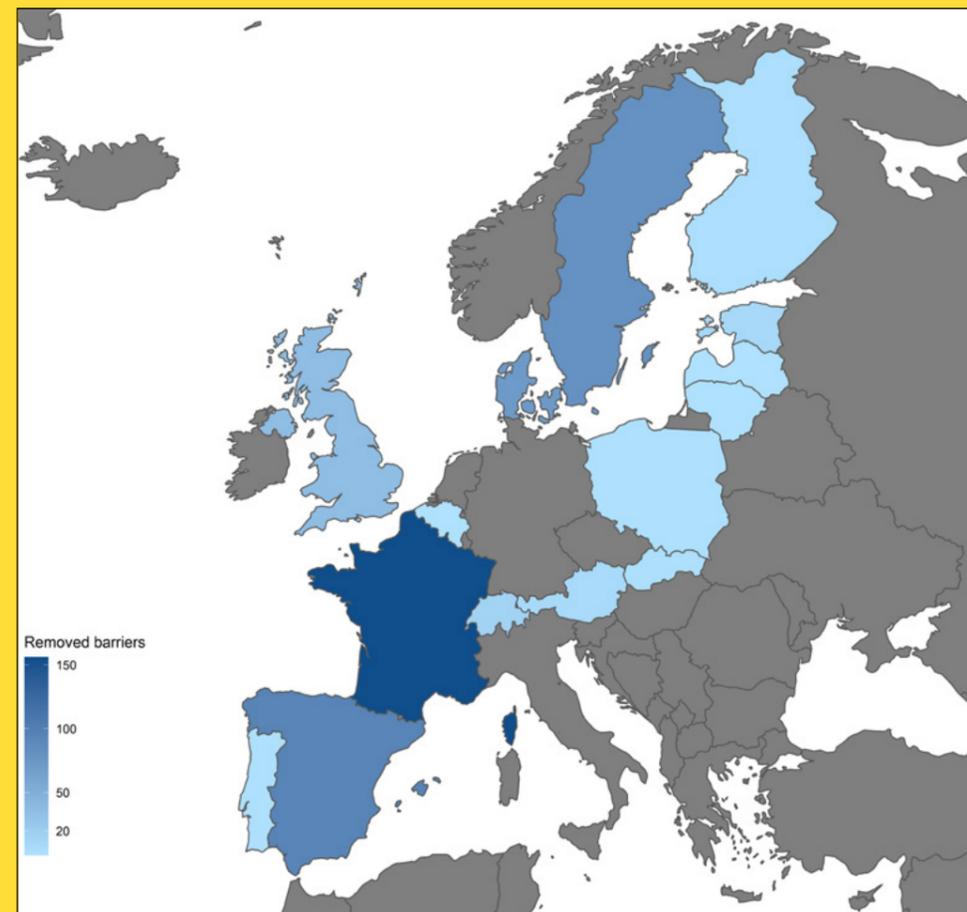
Figure 3. Map of European countries that reported barrier removals in 2023. Colour gradient refers to the number of removals per country. Note: barrier removals which took place in England, Scotland, Wales and Northern Ireland are considered under UK as a single unit

Barrier removal has only occurred sporadically and has yet to be established as a mainstream river restoration tool in Southeastern Europe (<https://damremoval.eu/dam-removal-map-europe/>; Figure 3). To address this gap, a 1.2 million Euro project, *Scaling up dam removal: implementation plan for Southeastern Europe*, was initiated in the autumn of 2023. Funded by the European Open Rivers Programme and led by Dam Removal Europe and the World Fish Migration Foundation, the project brings together several local partners, such as Fauna & Flora, MedINA Greece and the WWF offices in Slovakia and Adria region (Figure 8). Other partners include Wetlands International Europe, European Rivers Network and WWF

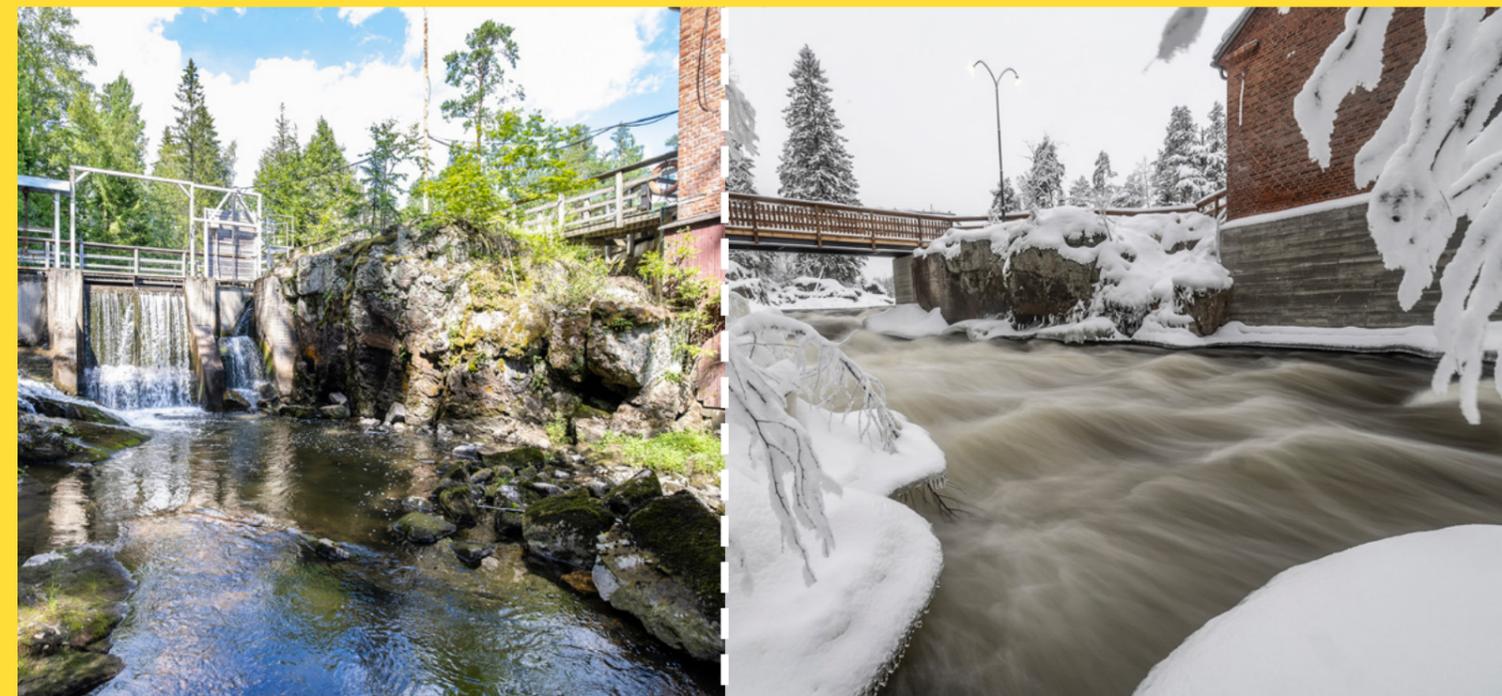
Figure 4. The removal site at Hiitolanjoki River, Finland: (left) before and (right) after the removal operations of the Ritakoski Dam © Mikko Nikkinen / Storymakers

Foundation for Recreation Area acquired the three operational hydropower plants, with the support of many financiers, including Rautjärvi municipality, WWF Finland and the Ministry of Agriculture and Forestry, including a large group of corporate partners and private citizens. In 2021, works started, with the removal of the Kangaskoski, the lowermost of the three dams, where ecological improvement was instantly shown, with salmon spawning nests being spotted in the newly opened section of the river only a few weeks later. Lahnasenkoski, the largest of the three dams, was demolished in July 2022, and Ritakoski Dam one year later (Figure 4).

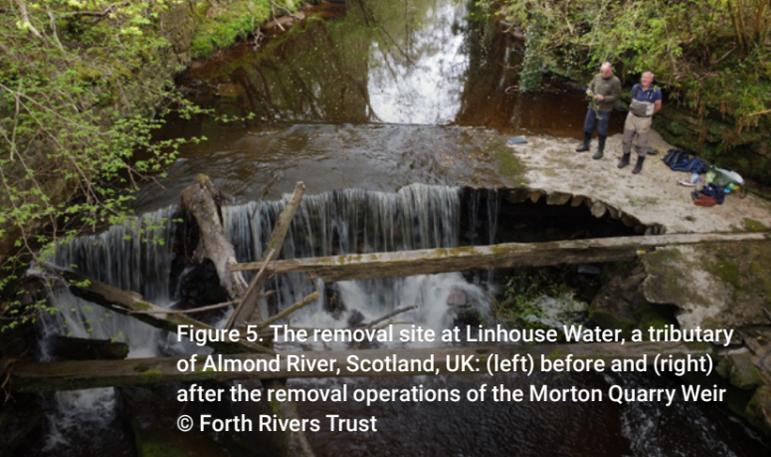
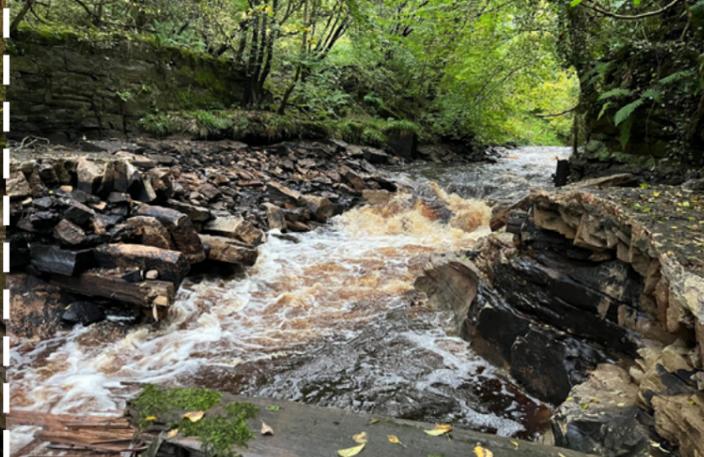
Figure 5. The removal site at Linhouse Water, a tributary of Almond River, Scotland, UK: (left) before and (right) after the removal operations of the Morton Quarry Weir © Forth Rivers Trust

Forth Rivers Trust staff removed the Morton Quarry Weir by hand (Figure 5)! In September-October 2023, this 2-m-high historic relic of the 1800s oil shale industry, situated on the Linhouse Water, a tributary of the Almond River in West Lothian, Scotland, UK was deconstructed. The weir was located in a steep gorge prohibiting access to heavy machinery and the costs associated with creating such access were exorbitant. Thus, the weir was dismantled by hand; a remarkable achievement thanks to the dedication and craftsmanship of the Forth Rivers Trust staff. The removal process involved stripping away the weir's top concrete layer as well as the natural cobblestone weir beneath. The cobblestones were redistributed downstream of the removal site to enhance the aquatic habitat in the Linhouse Water.

This was a novel, low-cost method that caused minimal disruption to the habitat, and could potentially be replicated in similar projects. The weir removal has restored access to 8.5 km of pristine fish spawning habitat upstream. Trout and salmon were spotted at the site attempting to migrate upstream during the removal works. Poaching incidents that used to occur downstream of the weir due to the blocked fish passage have now been eliminated. Surprisingly, during the removal, a 300-360 million years old fossil was revealed belonging to the genus *Lepidodendron* (Figure 6), an extinct genus of tree-sized lycopsid plants that lived during the Carboniferous Period.

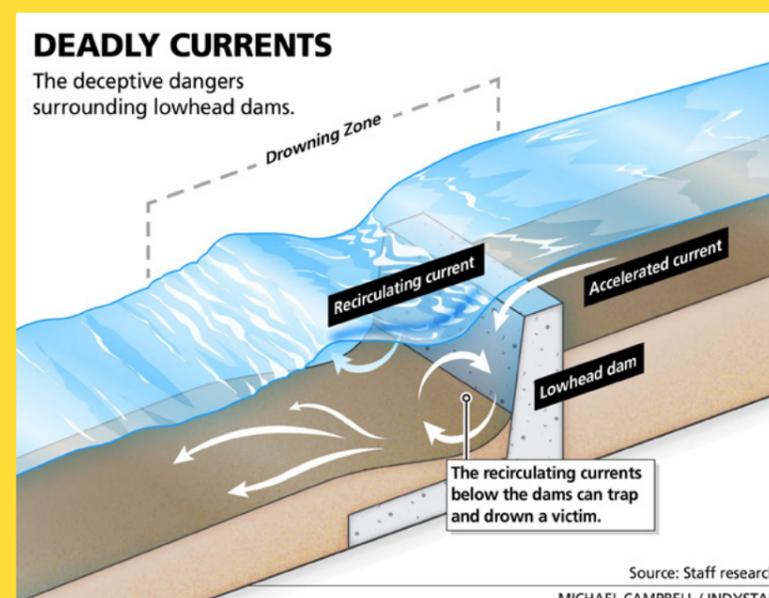
Figure 7. Low-head dams (i.e., weirs) that form an inescapably strong subsurface current (submerged hydraulic jump) are especially dangerous and are usually called "drowning machines" © Michael Campbell / INDYSTAR

Low-head dams (i.e., weirs) that are especially dangerous due to the formation of an inescapably strong subsurface current (submerged hydraulic jump) are usually called "drowning machines" (Figure 7). These structures have caused hundreds of fatalities in the U.S. in the last 20 years; more than any other kind of riverine barrier. Currently there is no overview of the accidents and fatalities that occur in European rivers due to such structures nor a centralized way to report them.
